## Service Bulletin

<b>Title</b>	DAX GENERATOR INNER BEARING SEAL AIR HOSES
<b>Reference</b>	SB0006A
<b>Date</b>	22 <sup>nd</sup> APRIL, 2010
<b>Category</b>	Service Bulletin

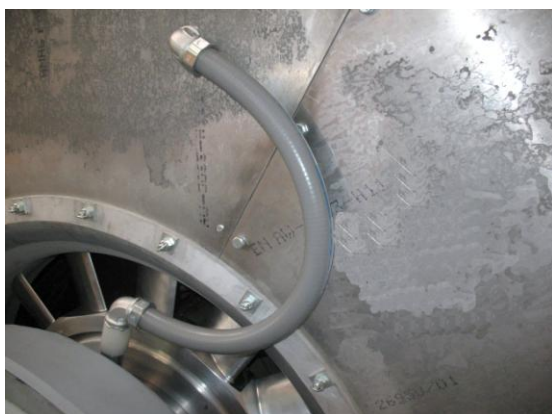
**Before**

As part of our continuous improvement process which draws on a number of sources including site feedback, we have enhanced the routing and locking of our inner bearing seal air hose design, as detailed within the photographs contained herein. This improved design is now incorporated on all new machines that are manufactured by Brush.

The probability of the inner bearing seal air hose failing is extremely low and from an installed base of over 2000 machines only a few isolated incidents have been recorded. Whilst these incidents are very rare and have occurred many years after the machines were manufactured, it should be noted that in the extreme case of a serious hose failure, the hose could come loose. This would cause oil leaks, due to loss of positive pressure on the inner seal, and create the potential possibility of the hose coming into contact with the aluminium generator fan which could lead to metallic particles then being ingested into the machine.
