CASE STUDY

Ploughing, Cable Laying & Jointing - Oransay, Isle of Skye

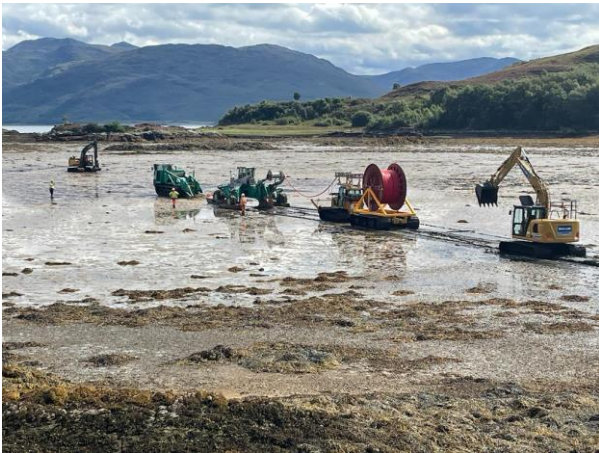
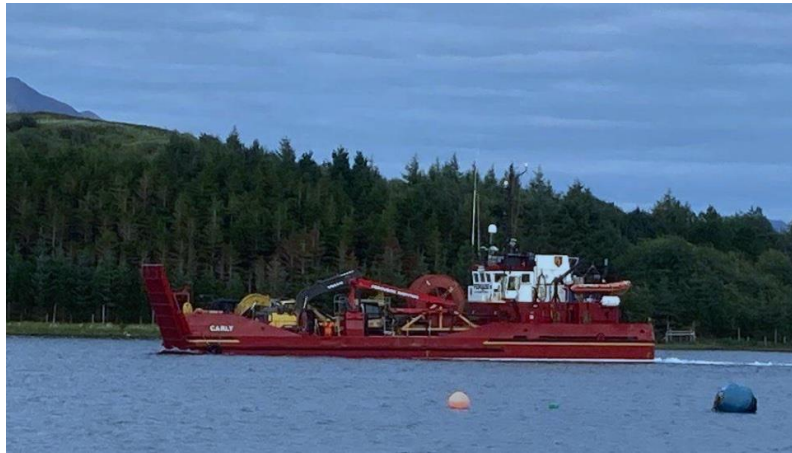
To deliver these vital SHEPD Network Fault works on the Isle of Oransay, Skye, McGowan Infrastructure deployed a state-of-the-art SpiderPlow. This innovative, efficient and environmentally friendly method for installing pipes and cables below ground utilises a mobile winch to move the plough through the soil, installing cables or pipes to depths of up to 2.5 metres. This methodology was particularly important to ensure faults in this line didn't reoccur, with this technique virtually eliminating the possibility of damage because downward pressure arising through compaction is deflected sideways due to lateral slicing.

With the SpiderPlow's adjustable wheels adapting to the terrain, a smooth laying bed was created, mitigating the need for additional sand bedding. Cables and pipes were inserted across a tidal mud flat without tensile stress, resulting in a superior quality job compared to traditional open trenching methods. This vital subsea electricity cable was replaced in a timely, cost effective, environmentally friendly manner to the satisfaction of the client.
